**Preliminary Geotechnical Engineering and  
Geologic Hazards Investigation for the  
Micron-Lehi Mixed Use Development  
Utah County, Utah**

GeoStrata Job No. 704-001

June 09, 2011

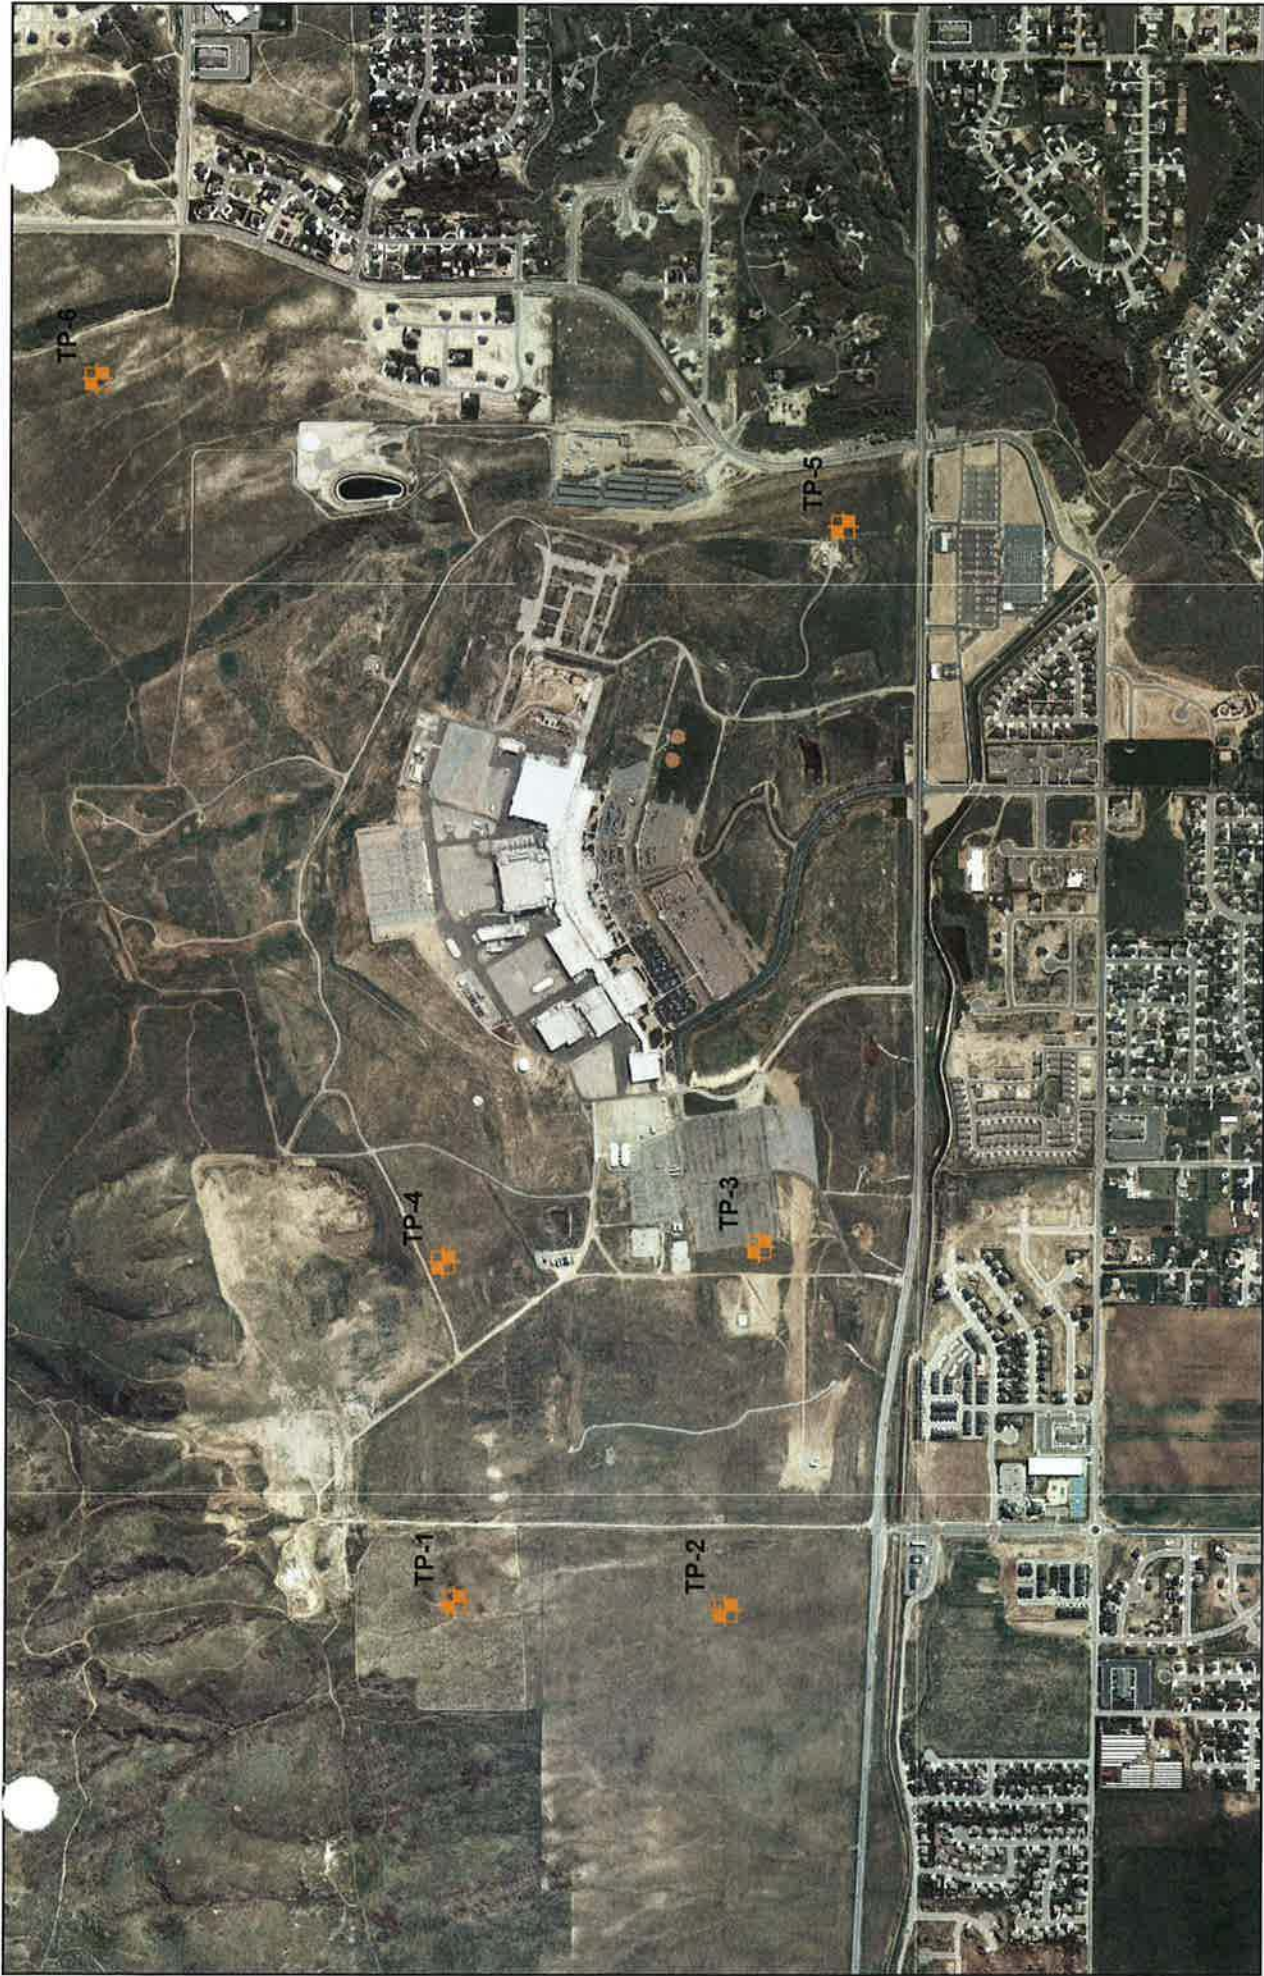
BASE MAP:  
2009 1 Foot Orthophotography obtained from the AGRC.  
All locations are Approximate.

Approx. Test Pit Location

As a part of this investigation, subsurface soil conditions at the site were explored by completing and logging six test pits to depths of approximately 8 to 9 ½ feet below the existing site grade. The approximate locations of the test pits are shown on the Site Exploration Map, Plate A-2 in Appendix A. A log of the subsurface conditions, as encountered in the test pits, was recorded by a qualified engineer and is presented in Appendix B, Plates B-1 through B-6. A Key to USCS Soil Symbols and Terminology used on the test pit logs is found on Plate B-7 in Appendix B.
